CLOSE CALL FALL OF PERSON

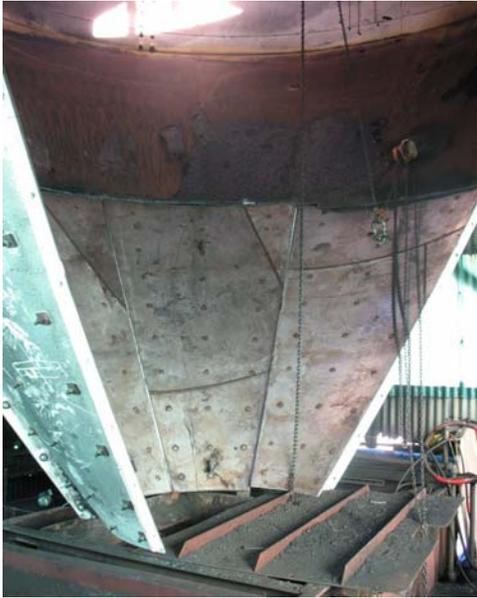
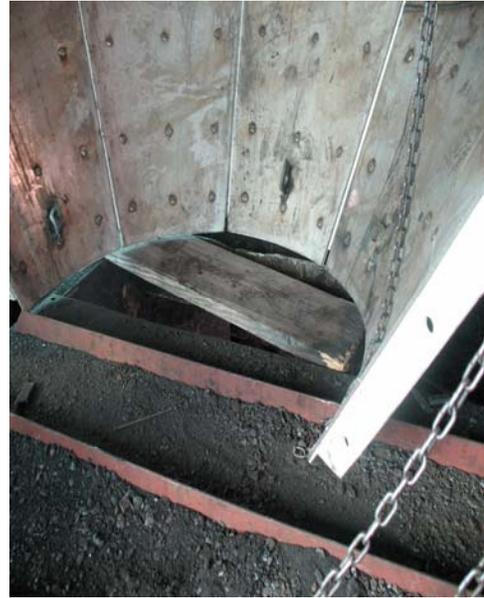
On December 4, 2007, a miner was injured while replacing the lining of a clean coal hopper. He was standing on a piece of wood plank, as shown, and, while using a crowbar to position a section of the lining, the board slipped, causing him to fall through the hopper some 25 feet to the ground below. The opening in the hopper had been covered with metal decking, which had been removed to provide clearance for the section of lining. The miner sustained a broken hip, back injuries, plus broken bones in his feet, legs, and arm.

1. Tie off or other wise secure your person when working in elevated areas.
2. Always work from a stable position.
3. Guard or secure all open areas where work is being performed.
4. Take the time to stop, look, analyze, and manage the job before beginning work.
